Manhole Inspection Summary

Manhole # S35AA2009MH

Location Address: **307 TAPLOW RD**

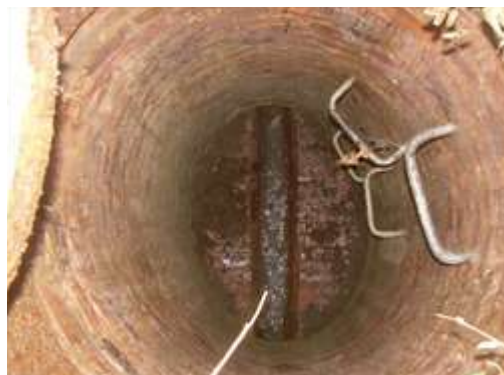
Top View

Evidence of surcharge - Bench debris.

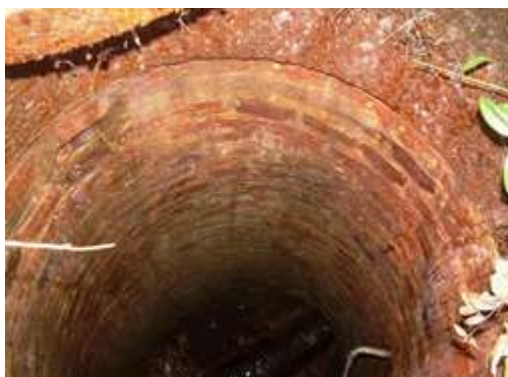
Defect

Adjustment and Corbel root intrusion and infiltration - other side.

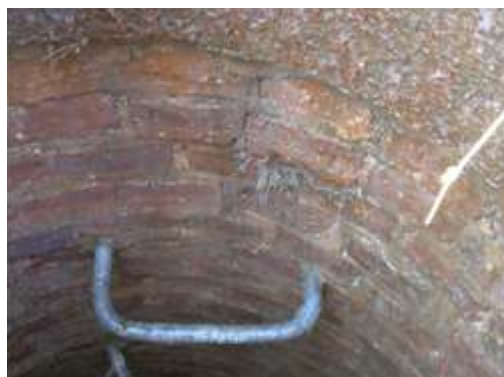
Defect

Adjustment and Corbel root intrusion and infiltration.

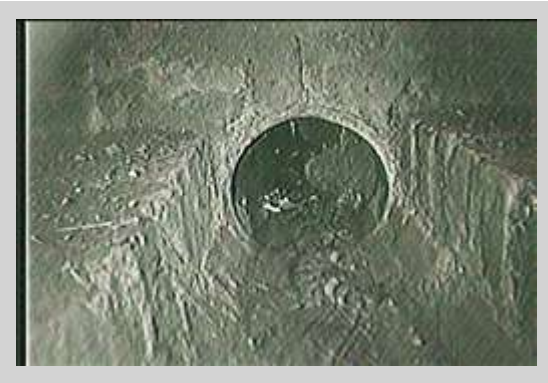
8 in. Circular Gravity Sewer Pipe Out @ 12 O'Clock

Condition: ☐ Sound ☐ Cracked ☒ **Root Intrusion** ☒ **Deteriorated** ☐ Leaks ☐ Debris

Channel deterioration.

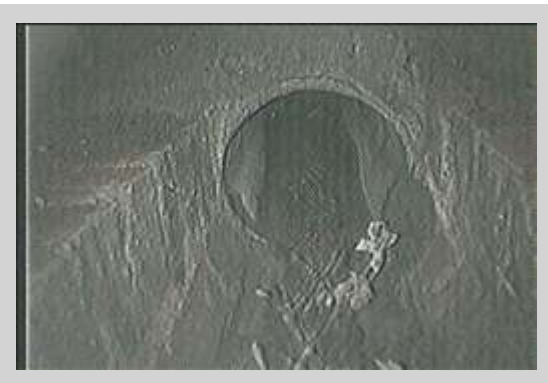
8 in. Circular Gravity Sewer Pipe In @ 6 O'Clock

Channel root intrusion.
